Rehabilitation Activities 2012

Some highlights of rehabilitation activities in 2012 undertaken in partnership with Government and the Tikina Namosi Landowners Committee (TNLC):

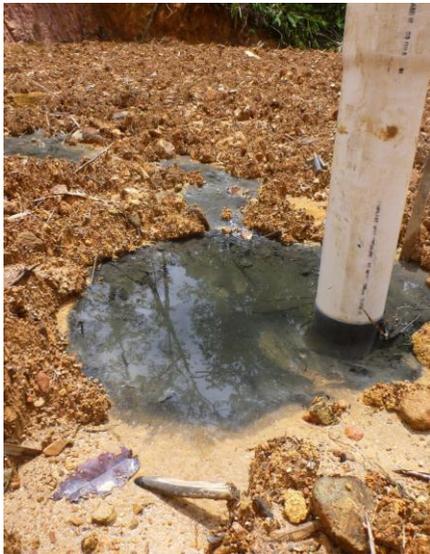
BEFORE

Issue: Blue liquid was emanating from drill hole on NVD 39. This blue liquid is a combination iron precipitate (dark in colour) derived from interaction of groundwater with mineralised rock and biodegrading drilling additives. The drill hole had been plugged but a slow, low volume seepage developed around the collar of the capped drill hole. Access issues had previously hindered rehabilitation.

Response: A 1m deep, 3m x 2m hole was dug to inspect cement cap of drill hole which was verified by the TNLC. A wooden filter box was built and installed with gravel packing. Ferns and plants replanted on site. This is monitored weekly and ground water flow has significantly decreased. It is anticipated that the hole will self-seal. Water quality monitoring has been routinely undertaken by the Mineral Resources Department and NJV and no impacts on the surrounding water quality has been detected.

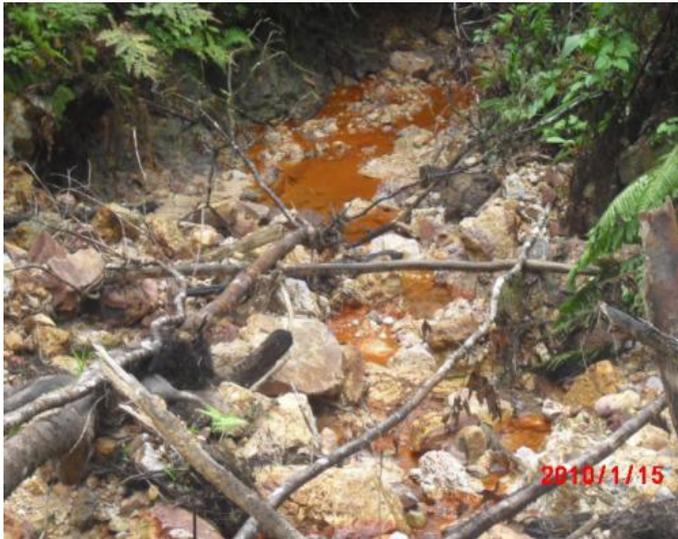
Picture provided

Issue: Landowners expressed concern about the discolouration of water at this Wainiveidrausa creek which they allege started from a proposed drill pad that was abandoned. They pointed to orange staining of the creek bed as in the picture provided.

Response: The Fiji Mineral Resources Department (MRD) undertook independent field mapping and water sampling of the creek as well as areas upstream and downstream. The independent MRD study found that the **“reason behind the discolouration / (staining) is due to the presence of iron oxide (ferric) that precipitate in water to settle and stain the creek bed.”** The whole process is natural when iron bearing rocks comes in contact with water. According to the study **“these are typical of areas with high mineralisation such as Wainikatama and Waisoi.”** The study further notes: **“It is also safe to assume that the characteristic nature of mineralisation at Waisoi east is a contributing factor to the acidic nature of Wainiveidrausa creek.”** NJV has also undertaken its own water quality studies with similar results. Both NJV and the independent MRD studies will continue to monitor the quality of water in these areas for a full season cycle (dry and wet season) with the results to be made available to TNLC.

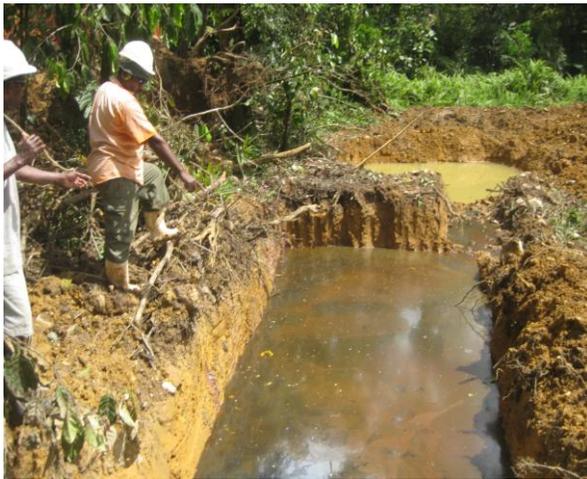
BEFORE

Issue: Catch sumps for NVD 40 filled up with surface water during heavy rainfall at the time of excavation. Clear groundwater was separated from drilling water (which contains rock cuttings, drilling additives) which were directed to two emergency sumps, dug to contain the drilling water immediately. The actions were successful with the sumps then pumped out (waters to landfill), sump liners buried, and sump backfilled. Materials at the bottom of the sump and the discoloured water consist of drill cuttings (containing dark rock), naturally occurring iron precipitate, and biodegrading drilling additives from the drilling process (which mix with naturally occurring bacteria and will create an odour while breaking down). Landowners expressed concern about the materials at the bottom of the sump, and the overflow of drilling water entering nearby river, as well as emergency sumps being dug without their permission.

Response: Liquid from all sumps were removed, and the two emergency sumps were backfilled and stabilised. Remaining sumps were covered with tarpaulin to minimise refilling by rain. Compensation was paid to landowners for emergency action without notification. Drilling at NVD 40 recommenced in October 2012.

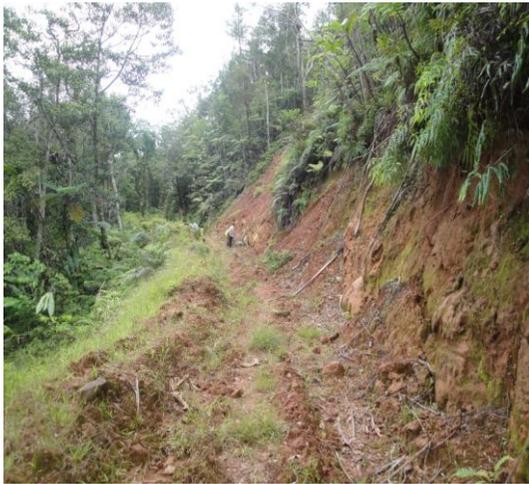
ACCESS TRACK AND LANDSLIP BEFORE

Issue: Landowners raised issues of landslides and soil erosion as well as rehabilitation of unused access tracks. Landslides have occurred both naturally and as a result of destabilisation of slopes following surface disturbance.

Response: Working in partnership with TNLC and with the support of landscape designers, plant operators and hydroseeder operators, NJV implemented a comprehensive landslide rehabilitation program. Replanting native plant species is the focus of the program with more than 100,000 trees and ferns planted to date. Two community nurseries are being established and rehabilitation work is being contracted out to local community members. Wire gabions have been used to prevent further landslides and install proper drainage control measures. Environmental management plans have been developed to identify and outline controls to prevent potential environmental impacts during the construction of access roads and drill sites, and during the operation of the drill rigs.
